Dynamic analysis of earth dam damaged by the 2011 Off the Pacific Coast of Tohoku Earthquake

Charatpangoon, Bhuddarak; Kiyono, Junji;
Furukawa, Aiko; Hansapinyo, Chayanon

Charatpangoon, Bhuddarak ...[et al]. Dynamic analysis of earth dam damaged by the 2011 Off the Pacific Coast of Tohoku Earthquake. Soil Dynamics and Earthquake Engineering 2014, 64: 50-62

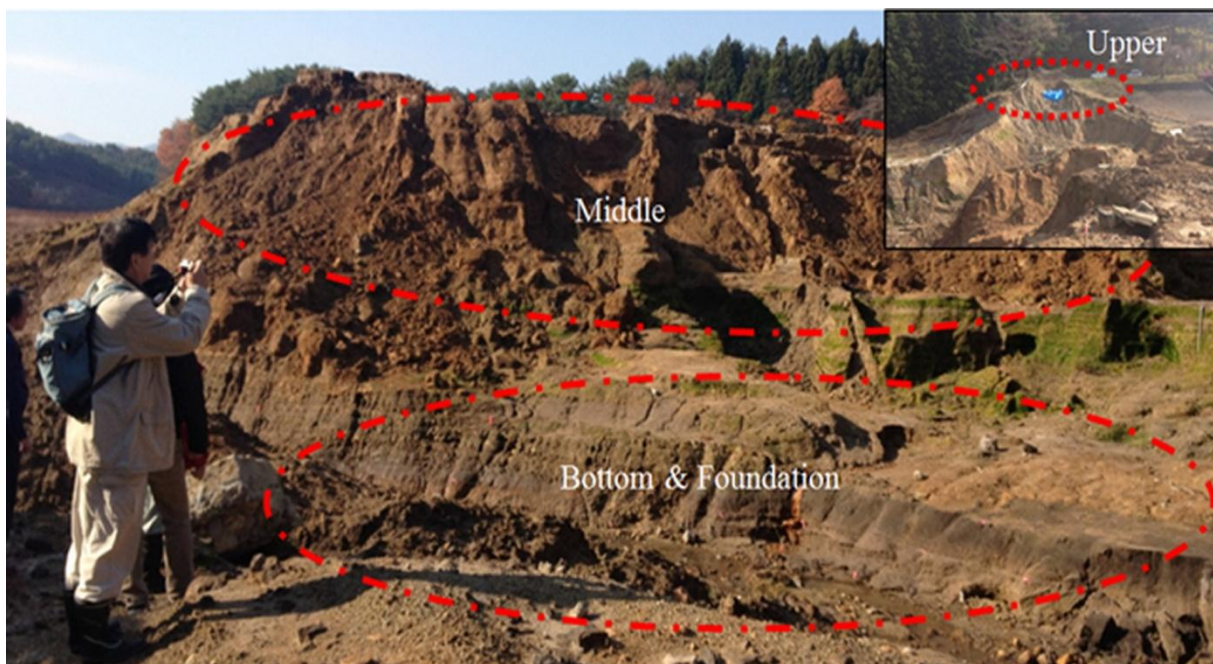
Photo1

Following the dam failure, most of the upper portion of the dam was washed away; the severe damage or breach location can be observed at the maximum cross section near the left abutment from downstream. On the opposite side, the remaining dam body consisted of the compacted fill materials. The foundations of the dam were exposed to ground level on the downstream side. From visual inspection of its properties, the dam body can be classified into three parts: upper, middle, and bottom.

Photo. 1. Remaining portion of the failed dam.

The upper layer comprises the top 6–8 m to the dam crest. Unfortunately, most of the upper layer was flushed away when the dam failed. However, on the left abutment, a portion of the upper embankment remains. Visual observation was performed on this section, which revealed that the fill material consists mainly of coarse sand of light color varying from light brown to gray (Photo. 1).

The bottom layer is between 4 and 6 m thick. This portion consists mainly of layers of loam-type clay and humic silty sand ranging from black to dark gray (Photo. 1). In addition, previous investigators [23,24] have indicated that some parts of the bottom layer consist mainly of dark brown sand and gravel. The black foundation material of the dam consists of organic residuals mixed with clay and silt.

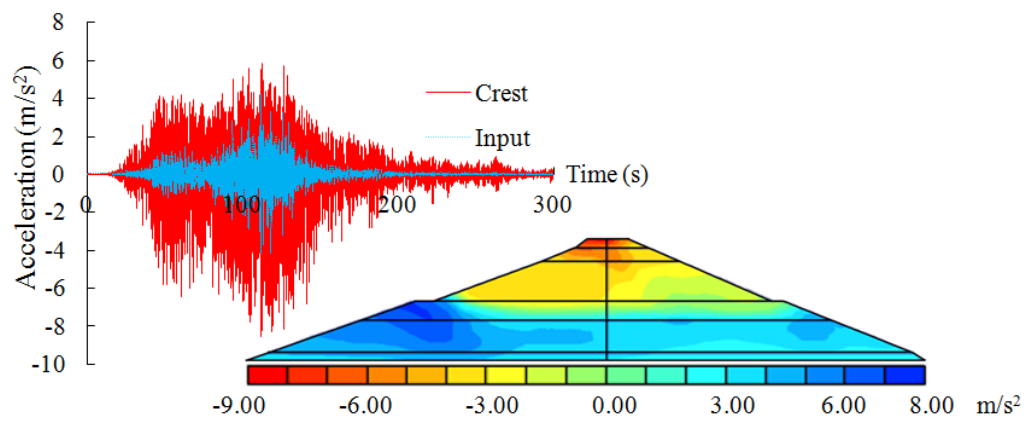
Fig12

Results show that larger maximum crest acceleration can be obtained using inverse phase of the observed and simulated motions. Therefore, the acceleration contours at the time when the maximum acceleration reached the dam crest are shown in Figs. 12 and 13 for inverse phase of the observed and simulated motions, respectively. By using the observed motion, the maximum crest acceleration is determined to be 7.42 m/s² and 8.56 m/s² accelerating towards the upstream direction at the time of 104.45 s and 111.60 s for normal and inverse phase motion (Fig. 12), respectively. For the simulated earthquake, the maximum crest acceleration is 7.60 m/s² acting towards the upstream direction at the time of 72.78 s. Similarly, for its inverse phase, the crest experienced the maximum acceleration moving towards the upstream side with a magnitude of about 7.65 m/s² at 71.24 s (Fig. 13).

Fig. 12. Acceleration contours (inverse phase of observed motion).

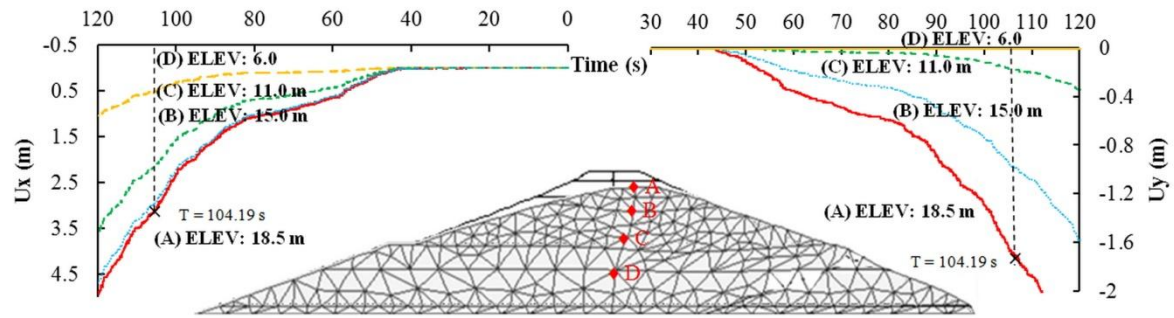
Fig14

Fig. 14 shows the deformed mesh at 104.19 s and its corresponding displacement curves when subjected to the observed motion. It can be seen that the entire dam body was moved in the downstream direction. As time increases, plastic deformations were accumulated. This caused the permanent horizontal displacement U_x of 2.95 m, and crest settlement U_y reached 1.80 m at 104.19 s; this is considered as the point of dam failure due to the loss of freeboard. Settlements at other observation points yield a similar tendency, but the settlements were less with decreasing dam height.

Fig. 14. Deformed mesh at 104.19 s using observed motion.

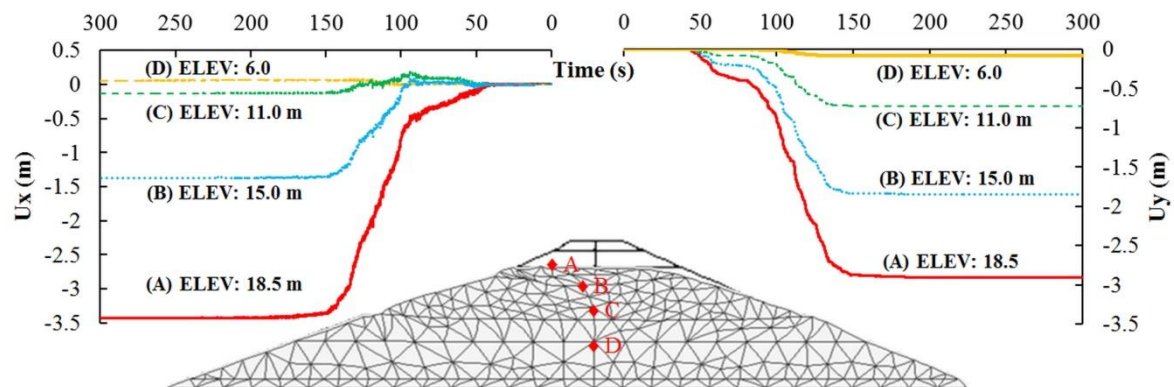
Fig15

In addition, the deformed meshes and deformation curves in both directions, at the end of the shaking using the inverse phase of the observed and simulated ground motion, are shown in Figs. 15 and 16. These indicate that both horizontal and vertical displacements fluctuated during the earthquake and settled continuously at a rapid rate, and then remained constant until the end of the excitation. The permanent horizontal displacement of the dam was 3.40 m (upstream side), 0.30 m, and 0.42 m for the inverse phase of the observed, simulated, and inverse phase of simulated motion, respectively. The vertical displacement at the dam crest reached 2.90 m, 0.63 m, and 0.60 m for the inverse phase of the observed, simulated, and inverse phase of simulated motion, respectively. As a result, by considering overtopping failure, the dam was able to withstand safely the simulated input motion except for the case of using the inverse phase of the observed motion, for which overflow is expected to occur.

According to the facts, the dam experienced overflow and subsequent breach. The one possible cause is that the significant settlement of the dam body led to the loss of freeboard. Thus, the observed motion does reflect the actual failure mechanism of the dam, whereas the simulated motion does not. However, all cases show that settlement is high, especially in the upper portion of the dam owing to its softness. For the changed phase, the observed motions show the significant effect of creating the displacement obtained from the normal and inverse phase, to be in opposite directions.

Fig. 15. Deformed mesh at end of the analysis using inverse phase of observed motion.

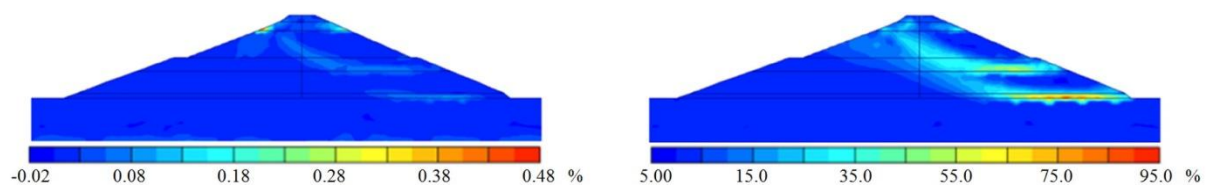
Fig17

Shear strain contours for various times obtained using the observed motion are shown in Fig. 17. Most of the dam body experienced an insignificant rate of shear strain. It can be seen that initially, large shear strains occurred in the upper portion, especially on the upstream side. Thereafter, the occurrences of large shear strain can be observed clearly on both sides of the dam in the middle and bottom portions of the downstream slope. This excessive level of shear strain may indicate a possible cause for the dam failure. Similarly, shear strain contours obtained from the remaining motions, yield almost the same pattern as the previous motion (Figs. 18 and 19). However, the exception is when using an inverse phase of the observed motion, for which large shear strains can be seen on the upstream slope instead of on the downstream slope.

The sequence of dam failure has been reported by previous researchers. Initially, the dam experienced excessive deformation or a slide on the upper portion of the upstream slope. This, together with a subsequent large slide that occurred on the downstream face, yielded a loss of freeboard and triggered the overflow that resulted in the breaching of the dam. Most numerical results show good agreement with this scenario, except for the case of using the inverse of the observed motion, which exhibited large strain appearing mainly on the upstream slope. The simulated motions also yield good agreement, but only with a smaller value of shear strain.

Fig. 17. Shear strain contours at 40 s and at 104.19 s using observed motion.

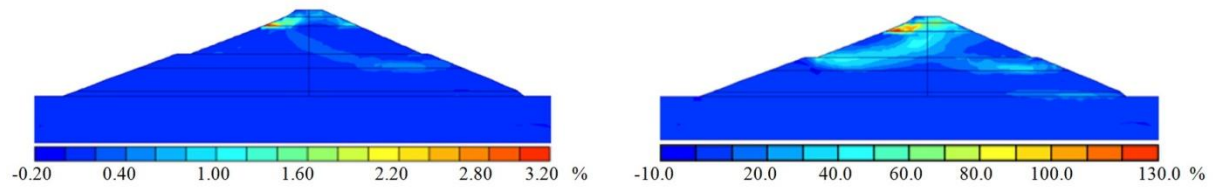
Fig18

Fig. 18. Shear strain contours at 40 s and at the end of motion using observed motion (inverse phase).

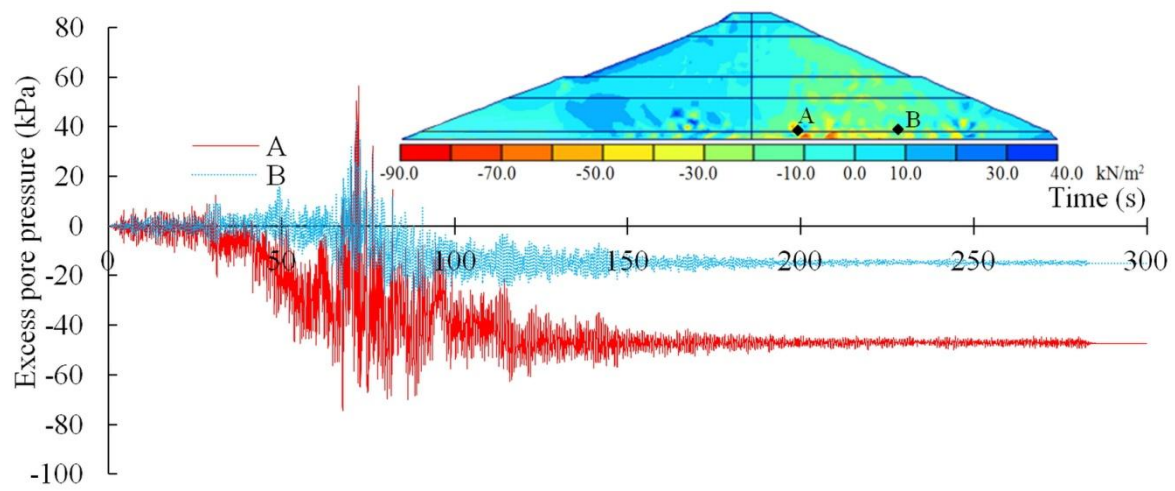
Fig20

The distribution of the excess pore pressure within the dam body and the records of the observation point A and B at 104.19 s using the observed motion are shown in Fig. 20. It can be seen that the excess pore pressure developed mostly at the downstream side. The maximum excess pore pressure was about 90 kPa and it can be found near the dam's base close to the dam center line. Besides, the suction or the positive excess pore pressure can be found on the upstream face and within dam's body on the upstream side. It can be seen that from the time history curves of the excess pore pressure at the

Fig. 20. Excess pore pressure.

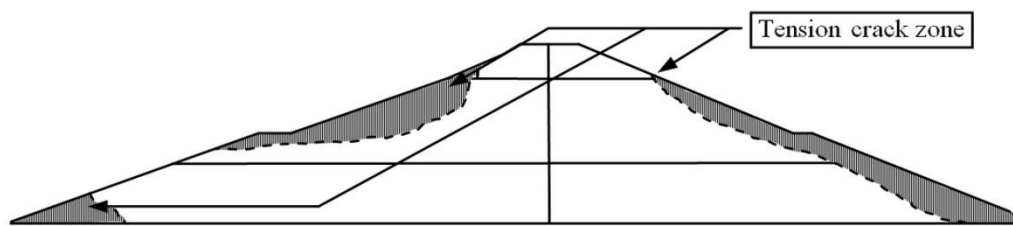
Fig21

In the analysis, it is possible to capture the tension crack during the shaking duration by illustrating the location in which the tensile stress does exceed the tensile strength. Fig. 21 summarizes the zone of the tension crack that occurred throughout the time of the analysis for both the observed and the simulated motion. It can be seen from both cases that the tension crack occurred similarly within the same location. This crack appeared clearly in the middle portion and at the toe for both sides. However, the tension crack on the upstream slope seems to penetrate deeper into the dam body. From this evidence, it would appear that sliding and internal erosion could be triggered, thereafter causing the failure of the dam.

Fig. 21. Tension crack zone.
